**MOUNTAIN STREET RESERVOIR DAM
MA 00082**

**MOUNTAIN STREET RESERVOIR DIKES
MA 01295**

**PHASE I INSPECTION REPORT
NATIONAL DAM INSPECTION PROGRAM**

OCTOBER 1980

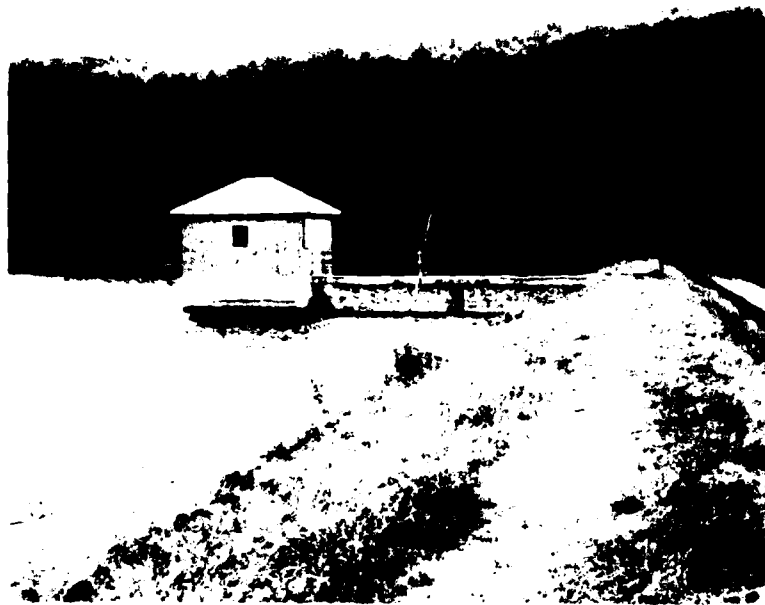
As shown in Photograph No. 1, the gatehouse is in poor condition, with heavy spalling, some stains and cracks in the concrete. The gatehouse service bridge is in very poor condition; major cracks exist in the pier and abutment (see Photographs No. 11, 12 and 13). Severe spalling and cracking was observed in the concrete bridge deck. Exposed reinforcing steel was also observed.

NO. 1 GATEHOUSE

- (5) Repair all spalled and deteriorated concrete on the gatehouse and the crack in the right training wall of the spillway.
 - (6) Remove accumulated soil, brush, vegetation, debris and loose stone from the crest and discharge channel of the spillway. The stoplog should also be removed.

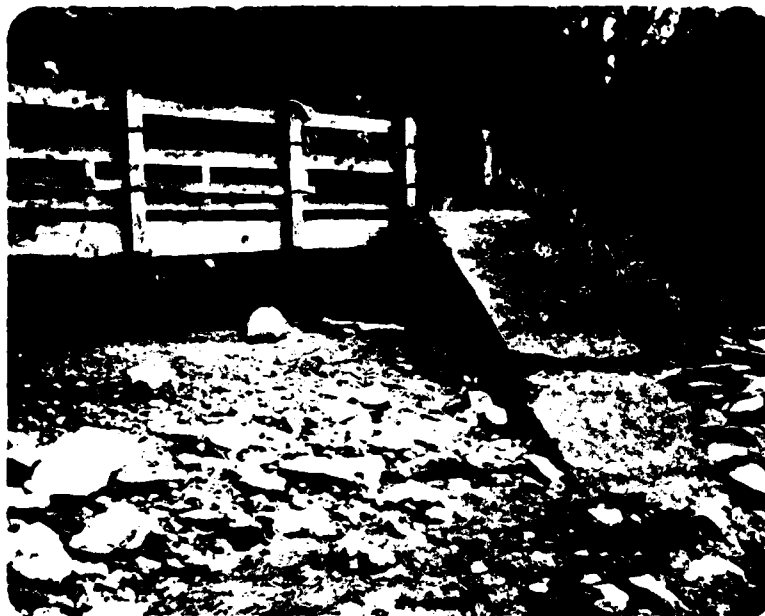
inspection, water was not discharging over the spillway. The concrete and stone masonry on the crest of the spillway was covered with soil up to the top of the stoplog. The concrete of the training walls is spalled and eroded at and below the normal pool level. A 1-inch wide horizontal crack extends completely across the right training wall (see Photograph No. 7). The timber vehicular bridge over the spillway was in fair condition. There is access to the stoplog from both spillway training walls which would permit removal of the boards during periods of high flow. At the present time the stoplog could not be removed because of the sediment in the spillway channel. The crest of the spillway contained some rubbish and wood debris.

b. Weir and Training Walls	Riprap slope left side concrete wall on right
General Condition of Concrete	Poor with heavy spalling 1" crack 3' long thru right side wall
Rust or Staining	Stained
Spalling	Heavy at and below water line
Any Visible Reinforcing	None visible
Any Seepage or Efflorescence	None visible
Drain Holes	None visible

NO. 7 SPILLWAY (NOTE CRACK IN TRAINING WALL)

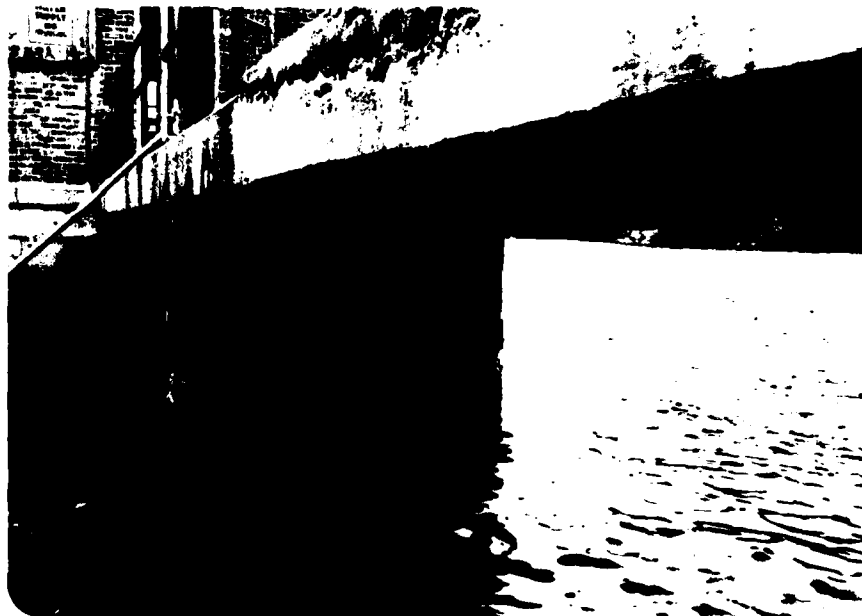
**NO. 12 CRACKED DECK ON GATEHOUSE SERVICE BRIDGE
TO GATEHOUSE**

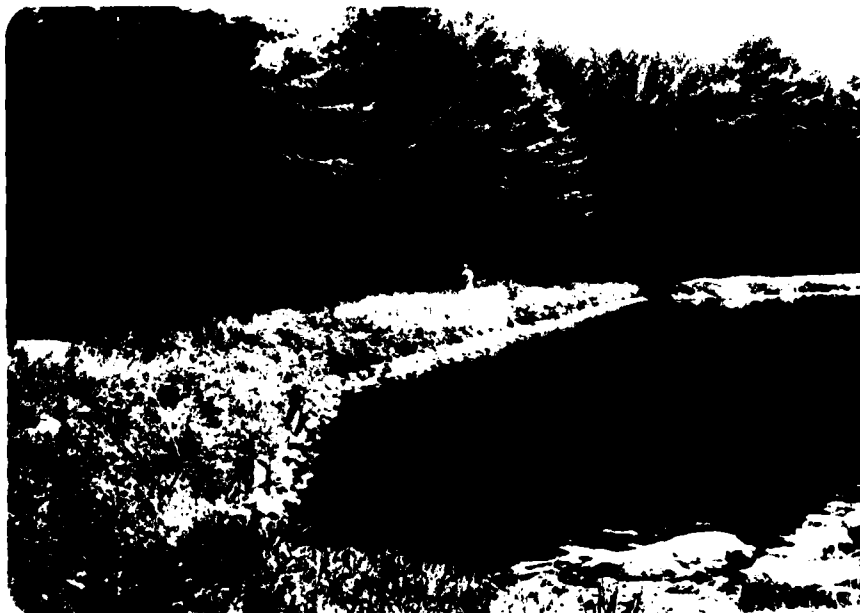
The dikes are in fair condition. A swampy area extends from the downstream toe of Dike No. 1 to Dike No. 2 and is a result of runoff collecting on the upstream side of the dikes. The riprap on the upstream slopes of both dikes is in good condition. The drain at Dike No. 1 was clear of debris; however, at both dikes the downstream slopes were covered with brush and trees (18 inches average diameter). There was no observable sloughing of the slopes.

NO. 14 DIKE 1

- (4) Clear trees, brush and roots from the dam and dike embankments, and to a distance of 25 feet from the toe of the dam. All stumps and roots removed should be backfilled with select materials in accordance with the recommendations of the Engineer.
